PROJECT
STATE OF CALIFORNIA, DGS
BOE ASSESSMENT

DESCRIPTION
WATER DAMAGE
SURVEY

LOCATION
6TH FLOOR

SHT NO. 7
SHT NAME A6

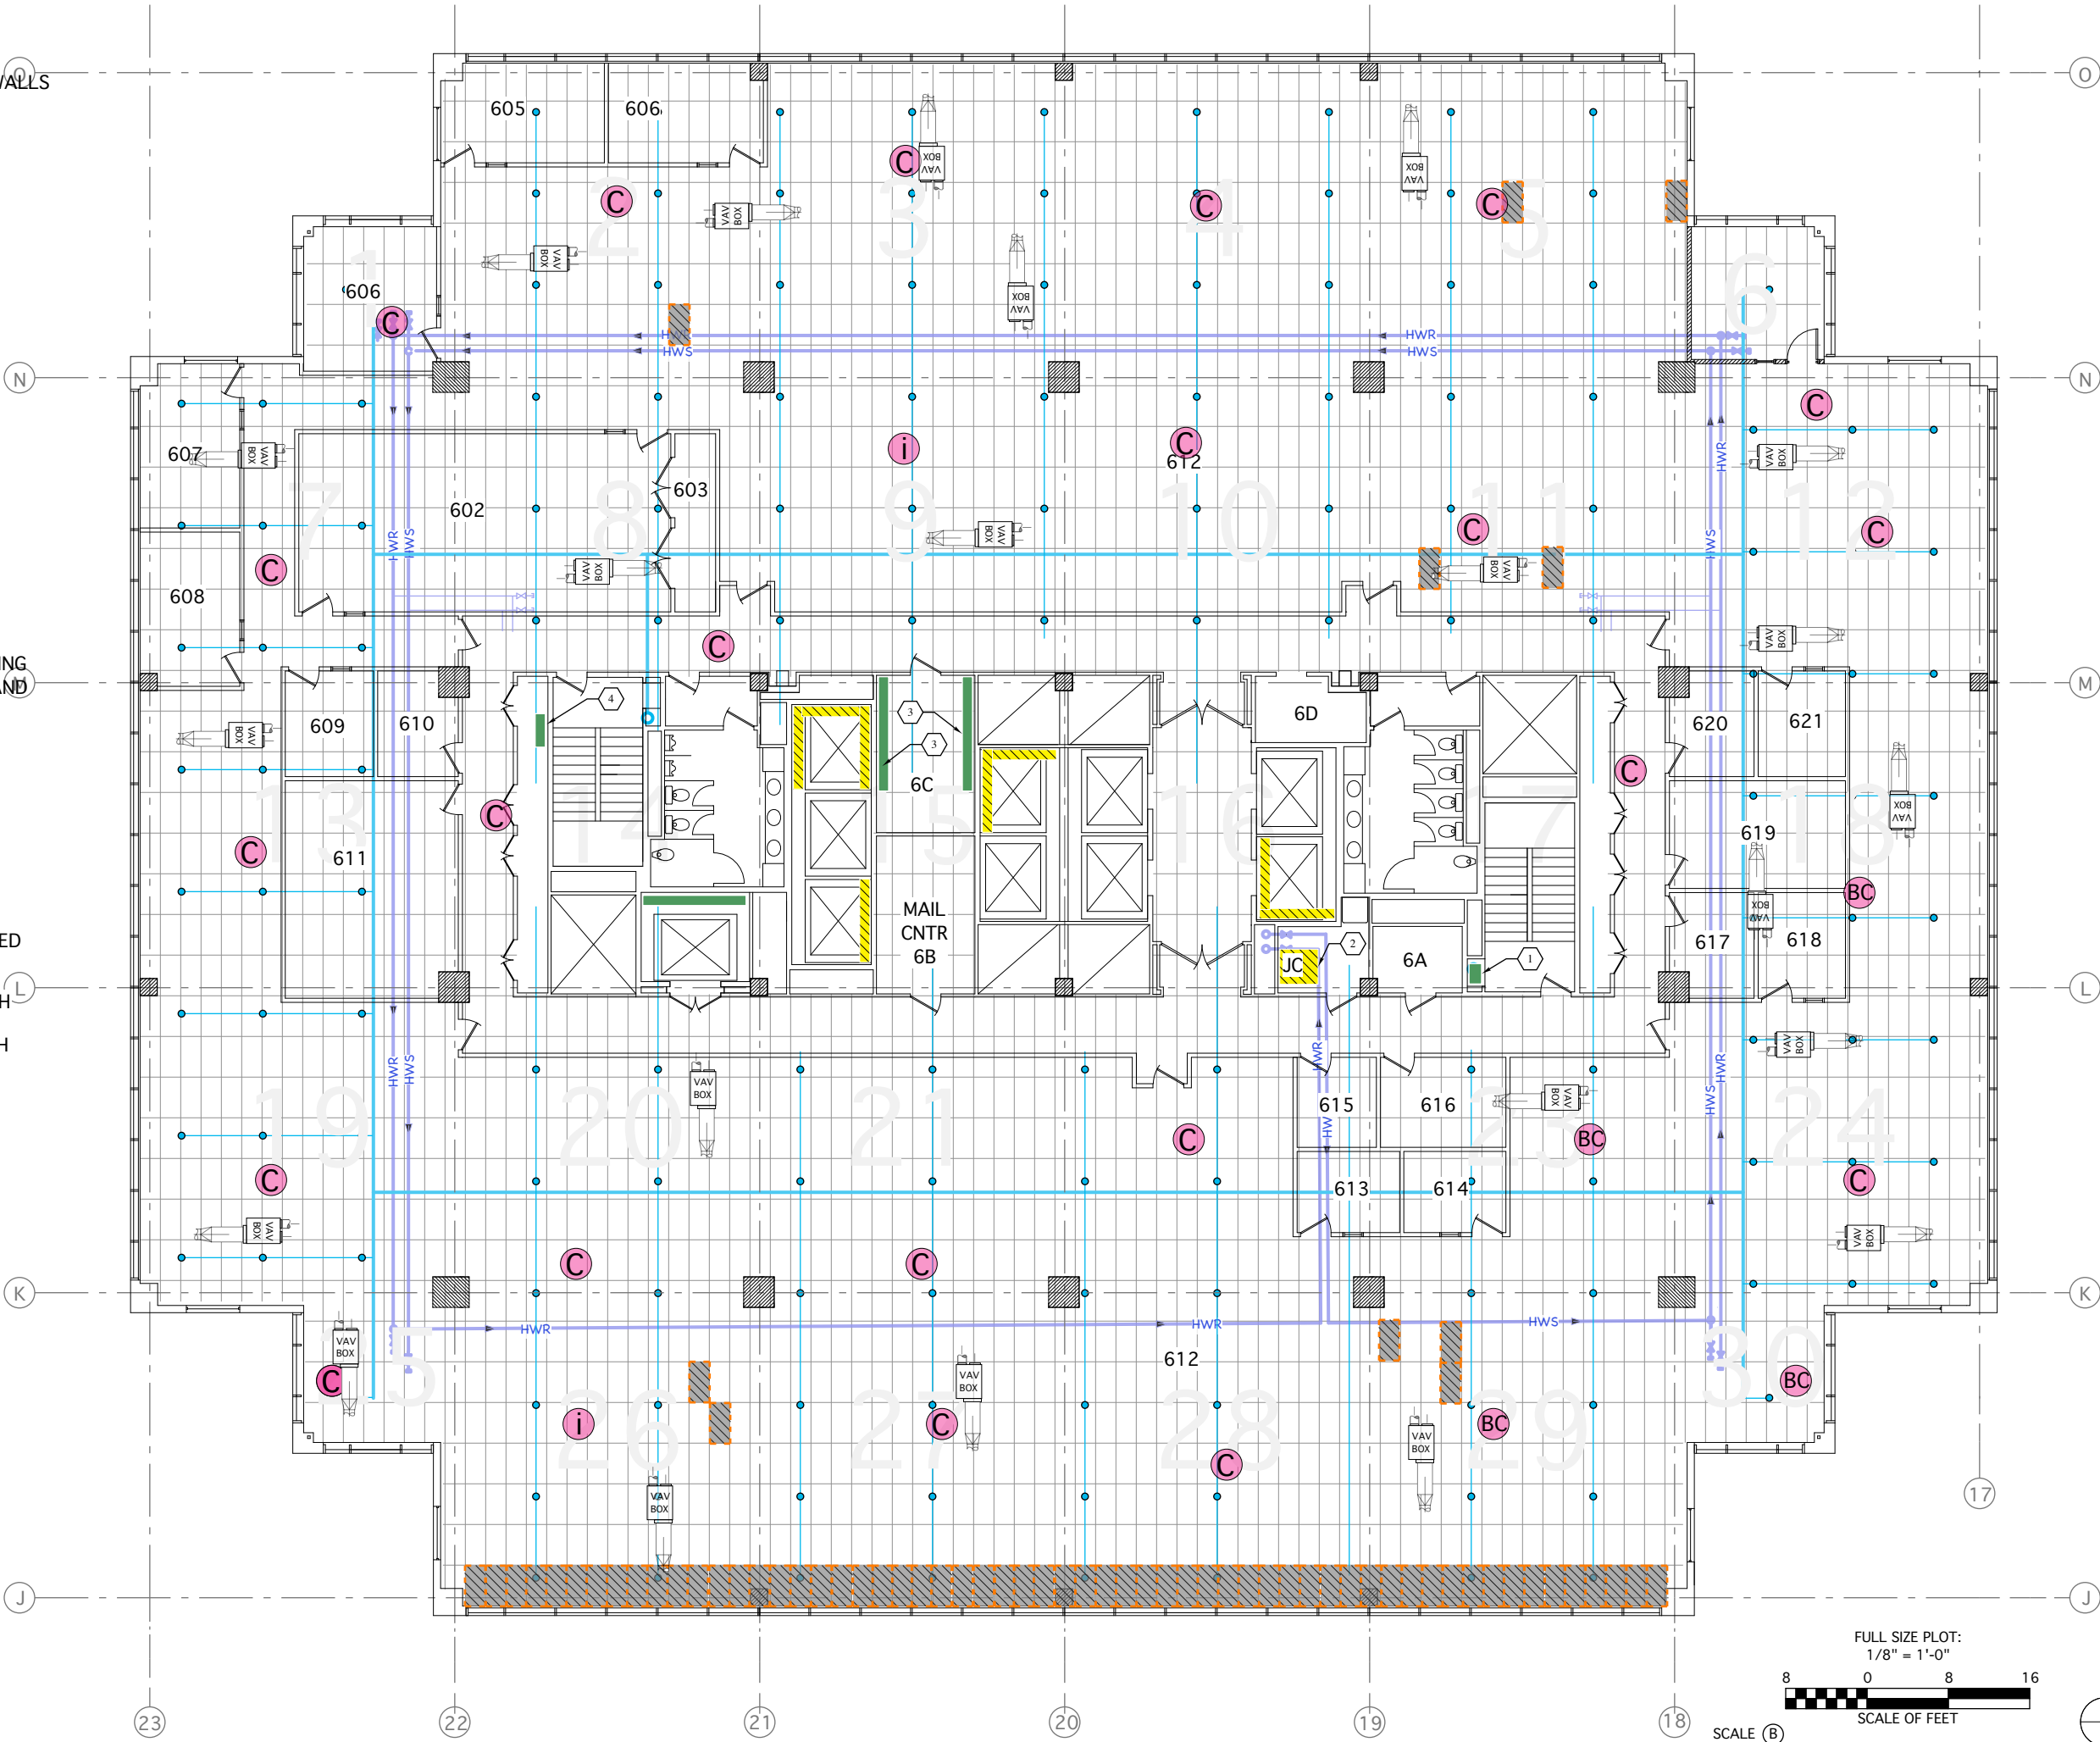
- 1 L/18.6 VMG 10 SF ON S+W WALLS
- 2 L/19.4 WS ON CEILING
- 3 M/20.5 VMG 100 SF AC
- 4 M/21.7 VMG 1 SF
